# Wheels of

**Recent claims might cause some operators to be concerned about certain 'improvements' on wheels for trailers and trucks. John Challen checks out the story so far and also highlights useful security products**

# fortune?

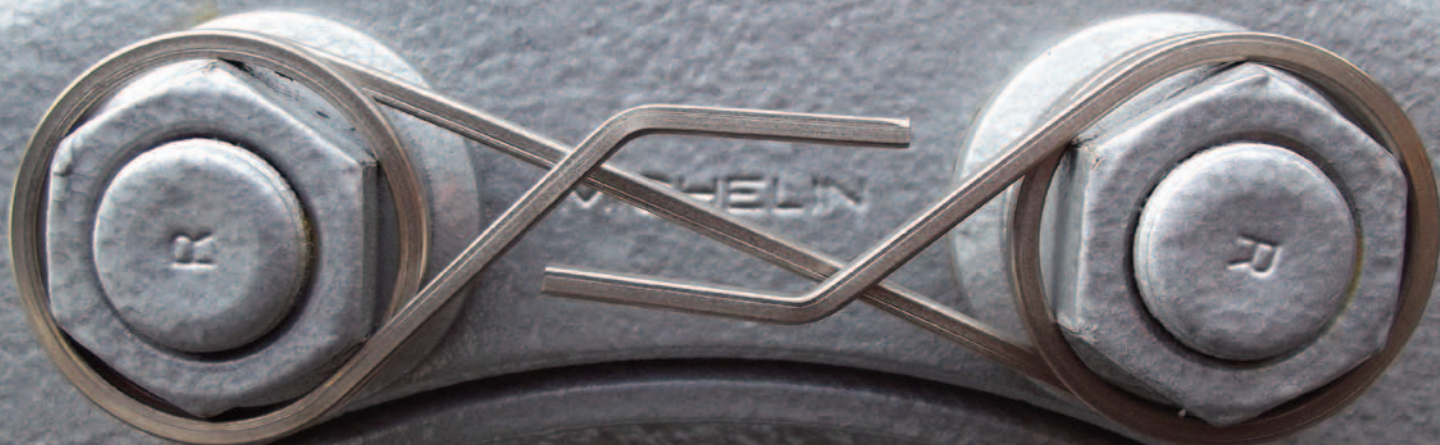
**Above: Checklock wheel nut retainer  
Below: Disc-Lock's three-piece Safety Wheel Nut assembly**

wheel nuts. However, this stainless steel wheel nut retention device doesn't require any fitting tools, so reducing fitment, removal and maintenance times for workshop staff.

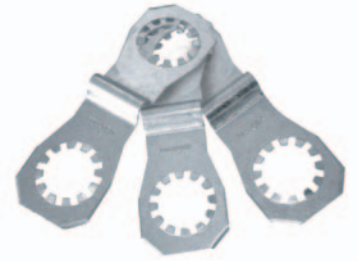
**Parma's Prolock fits over adjacent wheel nuts for extra security**

Another potential wheel loss prevention part is Parma's Prolock security measure. In the UK, the initial interest in its clamp came from bus companies, with the likes of Arriva Bus and London United investing. Following that exposure, a number of truck operators, such as HE Payne and Hoyer, have also specified the clamps – designed for wheel nuts in the 24 to 33mm diameter range – and Parma is expecting more to follow suit in the coming months.

Fitting over the top of two adjacent wheel nuts, these clamps aim to prevent detachment, even in the event of a loss of clamping force and, according to one unnamed operator, have proved a shrewd investment. Following trials against a similar product, an albeit unverified report for the mystery customer concluded that “in some combinations, deflection of the tabs did provide better retention force. The retention force of the standard Prolock is at least three times higher than provided by [similar products]”.
