Missing link

Although the advanced braking and electrical systems on today's articulated heavy vehicles are a huge step forward compared to previous technology, none of them can function without reliable 'suzie' connections between truck and trailer, reports Lucy Radley

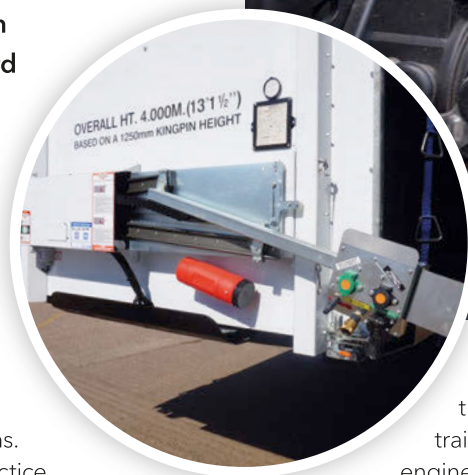
The first of these, released back in 1996, was the MAVIS rail - Montracon Articulated Vehicle Interconnection System. Other examples include Don-Bur's LowGlide Safe Ground Coupling System, the second generation of which has been improved to lower the height at which the suzies are connected (pictured above), and Lawrence David's Curved Ground Coupling. SDC also offers several sliding couplings (pictured, right), and points out an added advantage to using them. "As the truck turns 90° relative to the trailer, the coupling position on the trailer moves to the side, as opposed to the suzies stretching from the coupling point on the centre of the truck to the

coupling point on the centre of the trailer," explains SDC's engineering manager Jimmy Dorrian. "This shortens

the span the suzie has to reach, and therefore reduces the risk of it being over-stretched and broken."
