# Magic carpet ride

In a sense, commercial vehicles ride not on tyres but on the fat fingers of roller bearings housed inside wheel hubs. Although the traditional designs are proven to be robust, that does not mean they never go wrong, writes Toby Clark

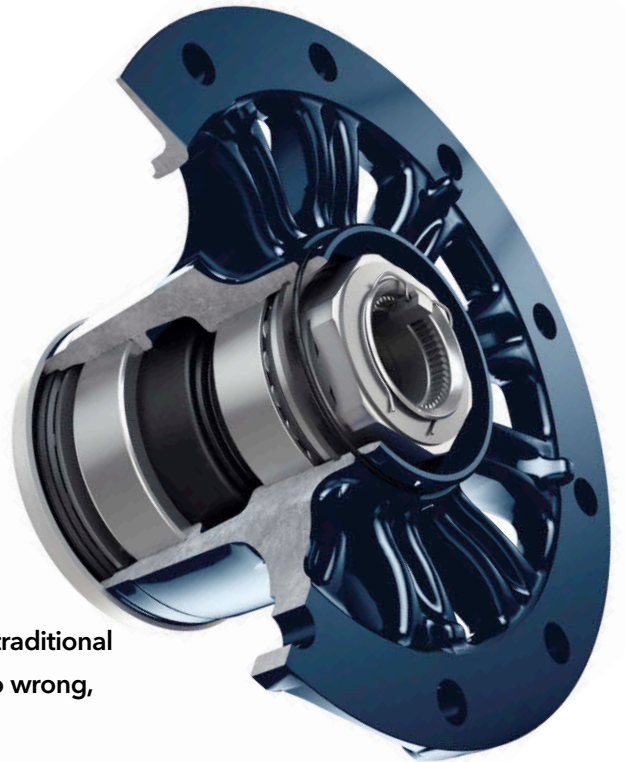
SKF has laid out the stages of integration of wheel bearings and hubs. They start with the single TRB with separate seals and lubricant, for assembly by the customer (a repair kit is shown below right). The next stage is a 'truck matched unit' (TMU) of paired TRBs.

Next comes the cassette-type truck hub unit 1 (THU1) which includes a pre-assembled pair of bearings, greased and sealed for life. The truck hub unit 2 (THU2) which adds an integrated flange and ABS ring; this is also available as a stepped unit, designed for stepped spindles, or as a full-flange unit

(THU2 FF) with wheel bolts built in (pictured below left).

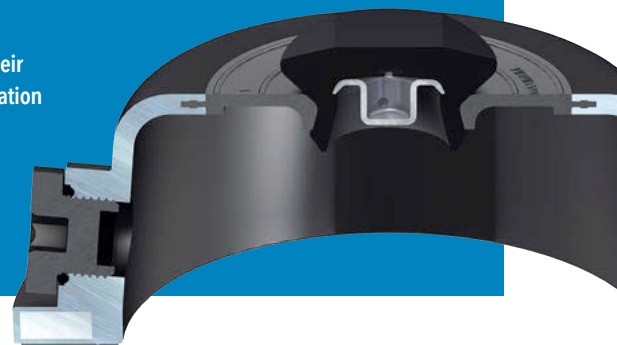
Hub caps might seem outmoded, but as a defence against bearing and seal damage they have their place. SKF says its hub caps offer “resistance against impact damage, weather, chemicals, UV radiation and ozone”. Rather more dramatically, they claim to give “protection from ricocheting rocks and flooded shipping docks”.

They can be specified with oil level sight windows, and incorporate other features, such as an embedded aluminium ring to evenly distribute load, and a centre-fill vented plug-in design, or a side-fill plug with an O-ring for extra leak protection and a magnet to trap metallic particles.
