Maintaining differentials

Putting new life into old drive axles. By Richard Simpson

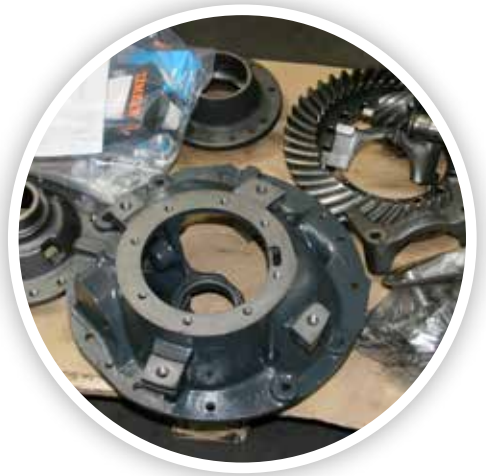
Given that running a freshly replaced pinion against one that has worn is likely to cause accelerated wear to both, it is wise to take the opportunity to strip and inspect the entire assembly and replace all wearing components, and this makes refurbishment preferable to a repair (an incoming axle pictured below; a finished unit is shown on p14).

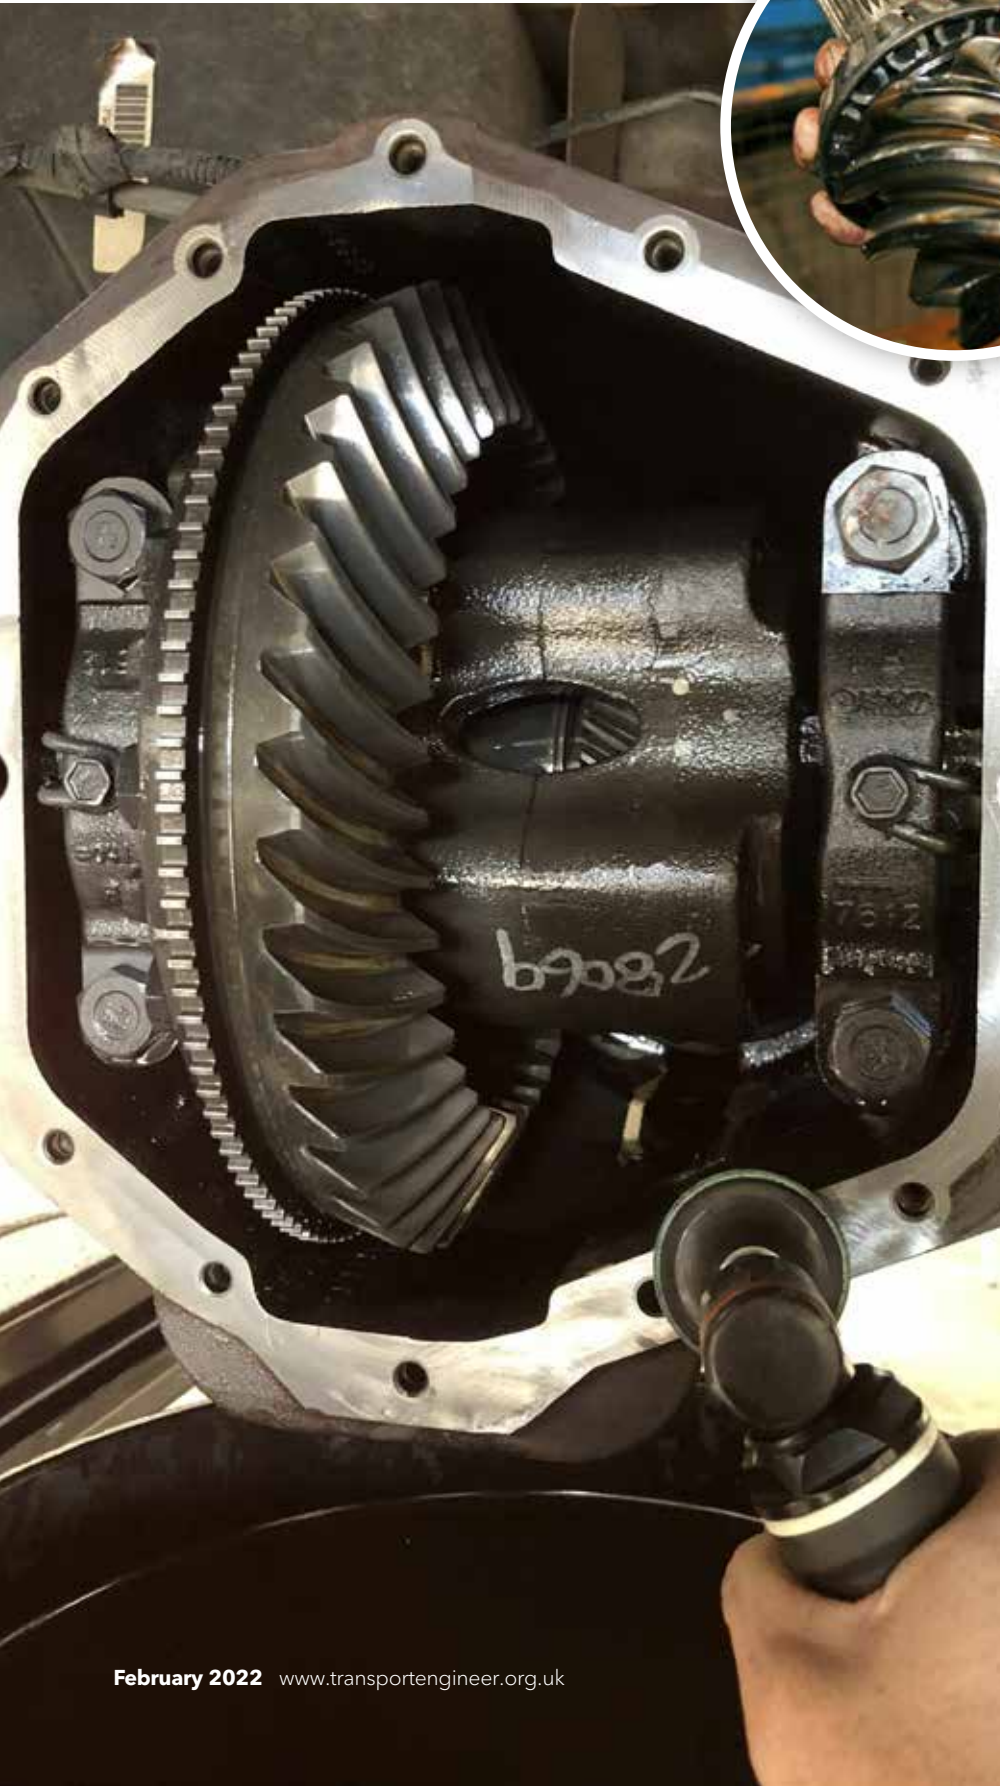
“It’s a specialist job that, if it is to be done successfully, requires specialist tools, specialist skills and a trained eye. All our products are tested before they leave here [pictured left], including an air-pressure test at 0.5bar to ensure a leak-free axle.

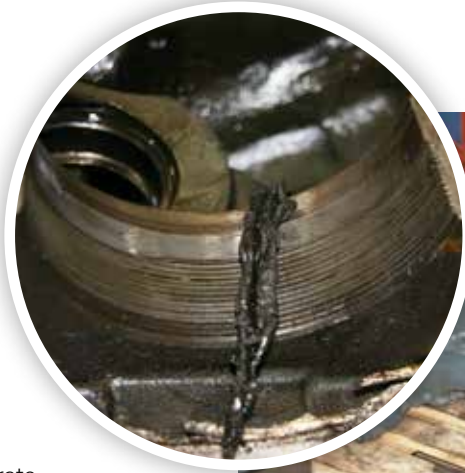
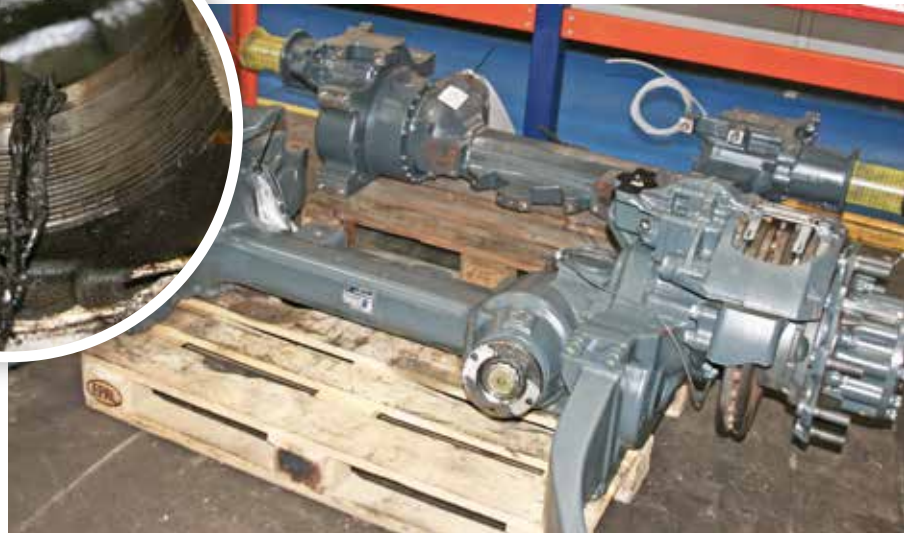
“RTV [room temperature vulcanising] silicone ‘instant gasket’ can be lethal to

the axle,” he reports (see overheated surface in inset image above). “Typically, people apply it in far too generous an amount, hoping it will make a better seal. They see it squeeze out of the external surfaces of the joint when it is torqued up, and think they have done a good job. But similar amounts are forced internally, become detached, get chopped up by the gears and end up obscuring the oil feeds to the bearings. The material itself is oil resistant. It won’t go away. We use a specialist sealant for the job [pictured, p12].
