Careless torque

When a wheel assembly detaches from a moving truck or bus, it can reach 150km/h and bounce 50m high, threatening anything in its path. Brian Tingham examines developments

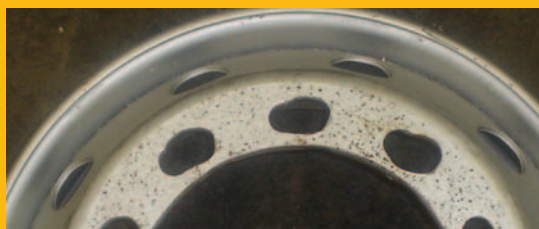
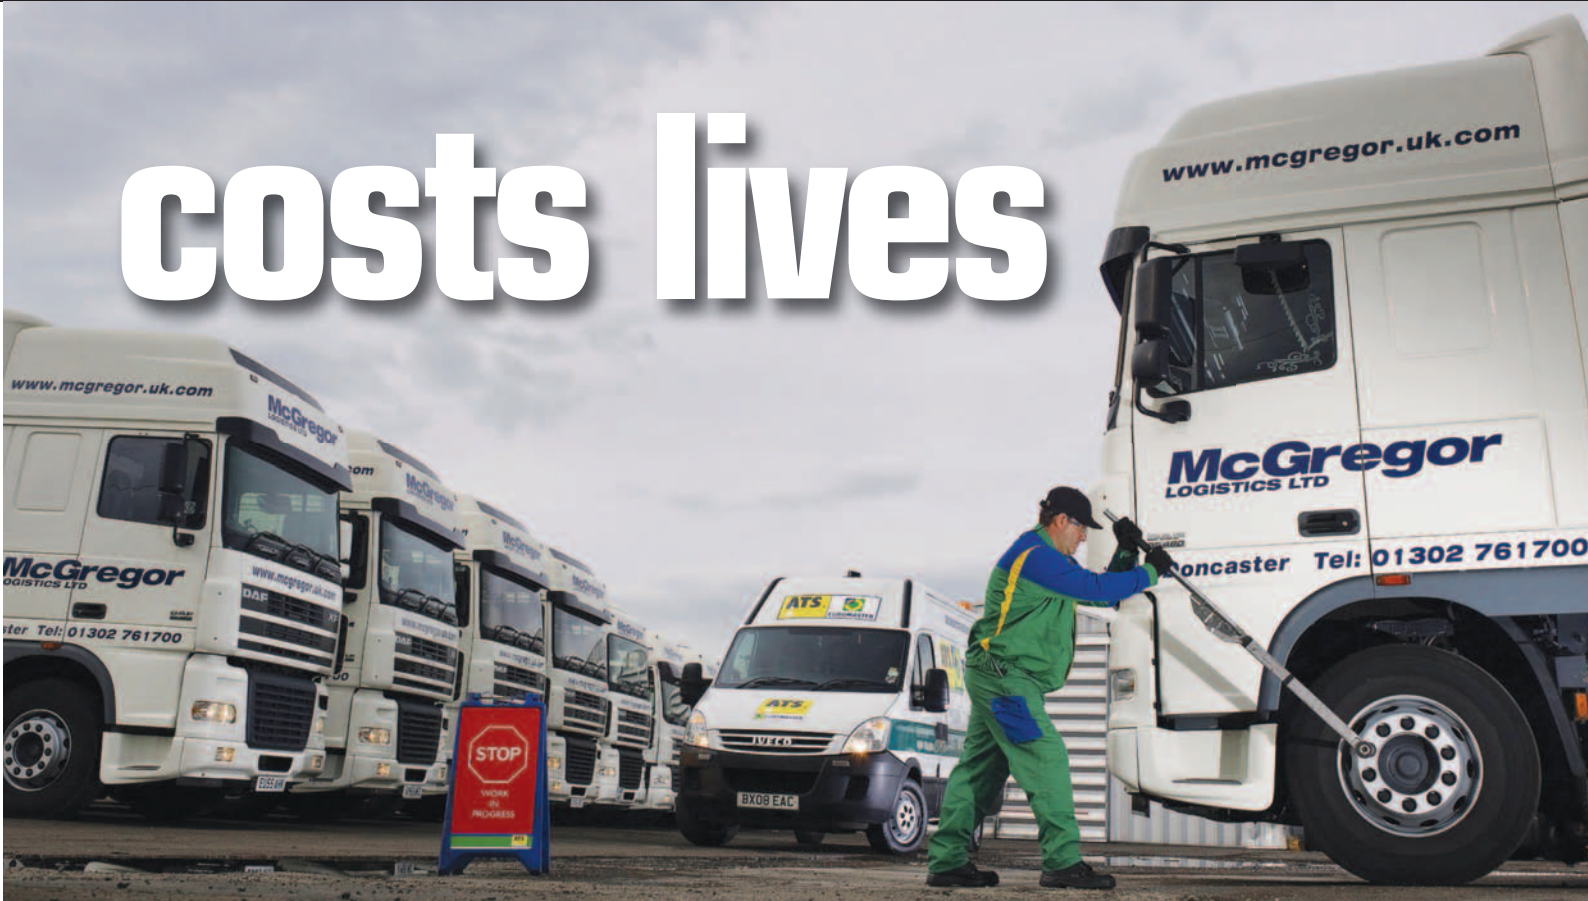
Right: some problems with wheels, nuts and studs should be immediately apparent to transport engineers – and locking nuts are only a partial solution

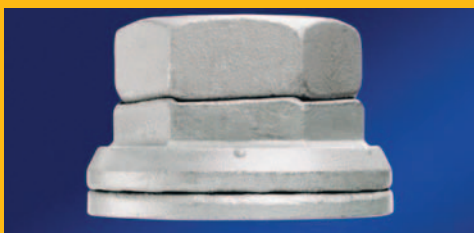
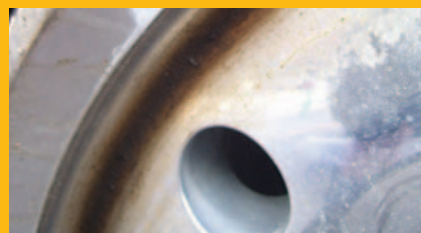
When it comes to wheel security, there is no room for anything other than best engineering practice
