EURO 6 UNCOVERED

As Euro 6 engines become more common, technicians need additional training. Brian Tingham talks to Keith Gallon, technical instructor with Scania

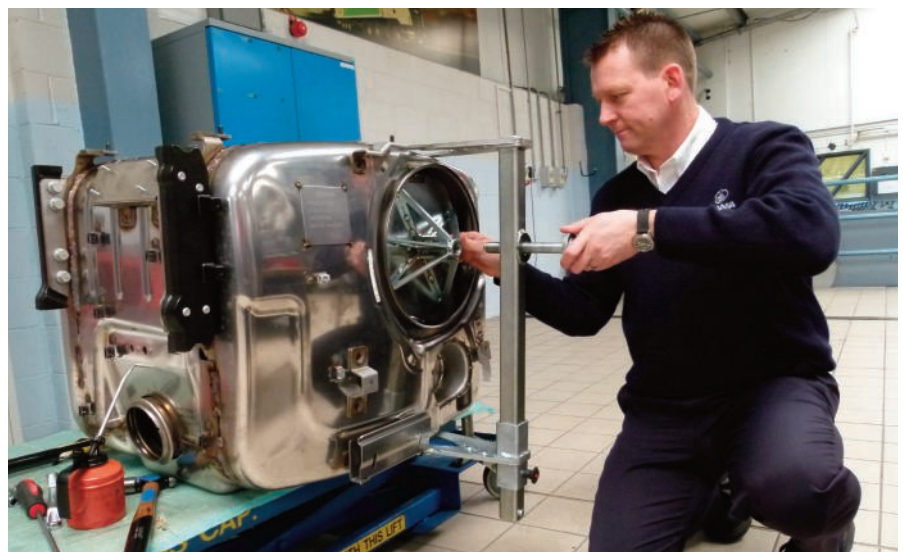
Scania's Keith Gallon prepares to extract a DPF assembly

- ✓ If the DPF needs checking (approx every 240,000km), remove the service cover, plug the sensor containments and extract the dosing unit.
- ✓ Before proceeding, use an endoscope to check inside the DOC for cracks, distortion, debris, oil residue (a sign of turbocharger problems), as well as urea stones, which can form – albeit rarely – when AdBlue is not injected correctly. Symptom: low NOx even when AdBlue is not dosed.

- ✓ Both the DOC and the particulate filter(s) are replaceable. Use special tool to draw out catalyst and filter packs, taking care to use blank plate to prevent loss of bolts.

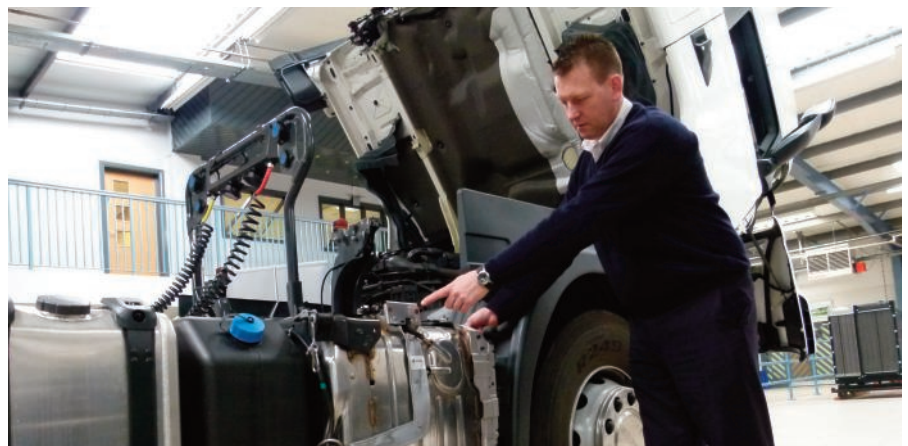
Euro 6 trucks' after-treatment packages have multiple sensors that monitor system health

Two NOx sensors provide readings both in front of and after the assembly. The first determines engine-out NOx (which varies according to the EGR, VGT, fuel injection, and inlet valve and exhaust brake settings) for its local controller. Its counterpart, at the exit, then provides feedback that the prescribed NOx level has been achieved.

Heat management, however, is critical for the efficient functioning of both the DPF and SCR. So the chemical factory has three temperature sensors – one before the DOC, one before the DPF and one before the SCR catalyst. Together, these enable the controller to regulate the temperature: first, for the DPF (so that it burns off soot and successfully runs its periodic regeneration); and second, for urea dosing. The latter has to be hot enough to enable the SCR reaction that knocks out NOx, but not so hot that AdBlue simply evaporates and blows through to the ammonia catalyst.

Finally, differential pressure (DP) sensors (before and after the DPF) look for pressure drops. Increasing DP indicates that the filter is blocking up. Incidentally, on Scania systems, the local controller links via CANbus to the EMU (engine management unit) – the pair effectively working in tandem. **TE**
